WNI-32 NCE Pro Cab Wi-Fi Interface Module

Compatibility, Firmware Issues and Workarounds

Technical Note on Intermittent Power-up via Red Button on Pro Cab

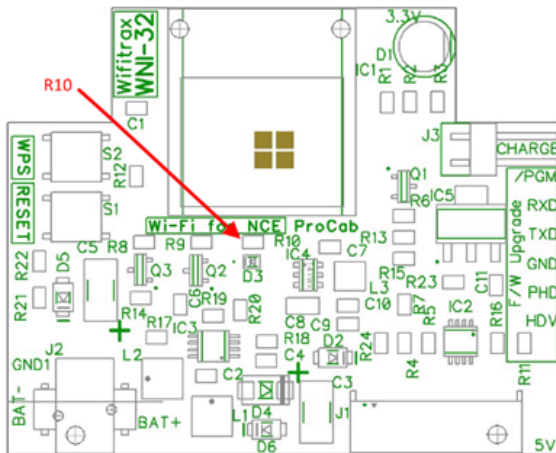
If pressing the red button results in the 3rd gold finger pattern to make contact with the two wake-up patterns, the result is that current from the WNI-32 flows through protection diodes on the output of the 74HC138B to its 5V power and thus reduces the voltage feeding back to the WNI-32 to about 1.5V which is not enough to enable the SEPIC converter.

So it turns on if the red button conductive coating does NOT contact that 3rd gold finger going to the decoder, even if only momentarily, to give it a chance to power up.

This explains how pressing the button slightly to the side, often causes successful power up.

The issue can be fixed by replacing the 10K resistor R10 with a 1K resistor which fixes the problem as it allows current to flow through the protection diode pathway described and yet still maintain enough voltage fed back to the WNI-32 to cause successful power up.

So the fix is to change R10 on the WNI-32 from 10K Ohm to 1K Ohm. The recommended component is RC0805FR-071KL, a Yageo component. This is a 1/8 Watt, 1%, 0805 resistor (0.08 inch x 0.05 inch). Any equivalent resistor will be acceptable.
